Benzalkonium runoff from roofs treated with biocides

M.C. Gromaire

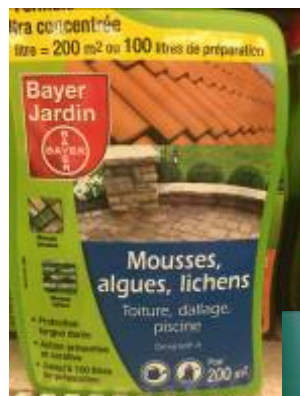
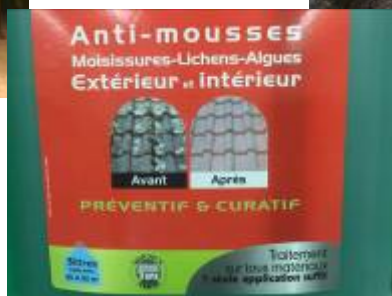
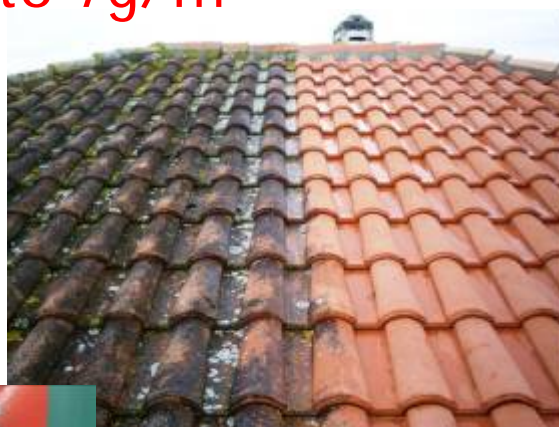
- Most frequent treatment: **de-mossing**
 - 1 / 4 private house owners already did it
 - Every 5 years on average
 - Professionals or DIY
- Biocide used: **benzalkonium chloride**
 - Numerous trademarks
- Normal dosage: **4 to 7g/m²**

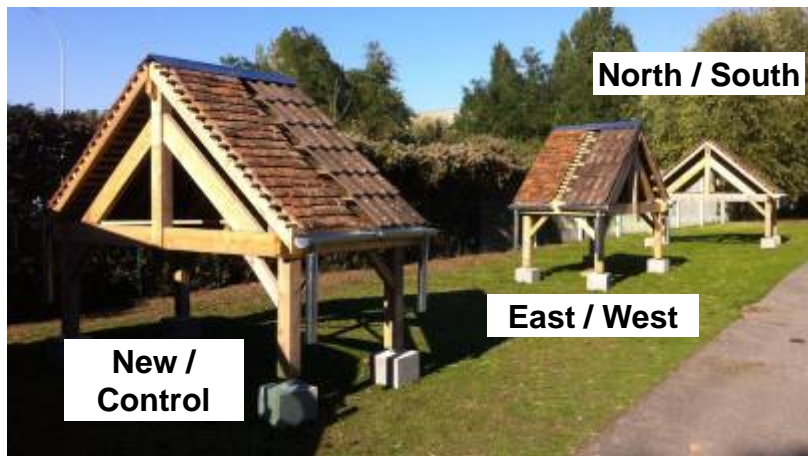
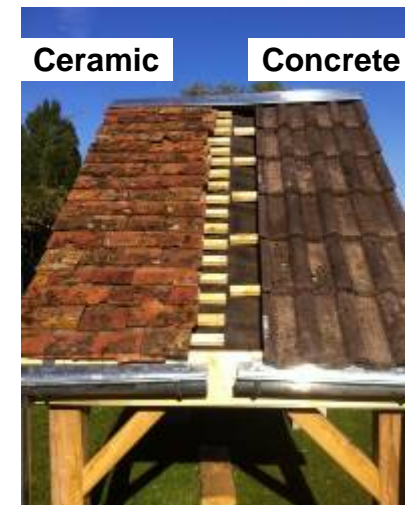
- 12 test roof frames

Materials	De-mossing treatment	Aspect	Exposition	Surface	Slope
Ceramic Tiles (CI) Concrete Tiles (Co)	No (controls)	Old	S	~ 1m ²	40°
	Yes	Old	N, S, E, W		
	Yes	New	N

- 13 month follow up after biocide treatment
 - First 5 successive rain events (50 mm, 1 month)
 - 4 rain events later on

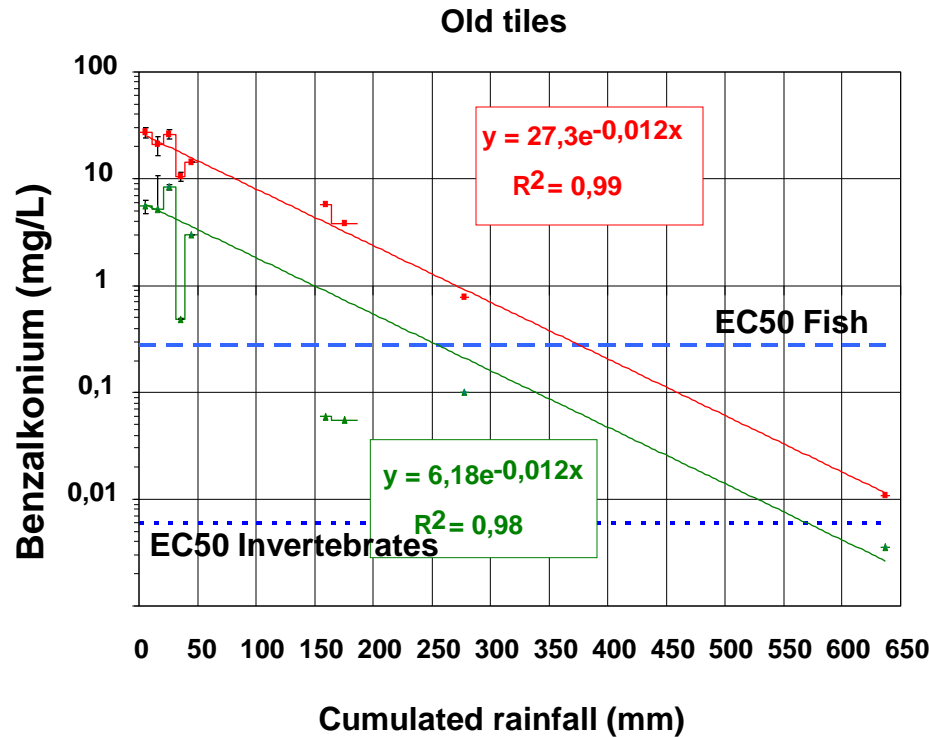
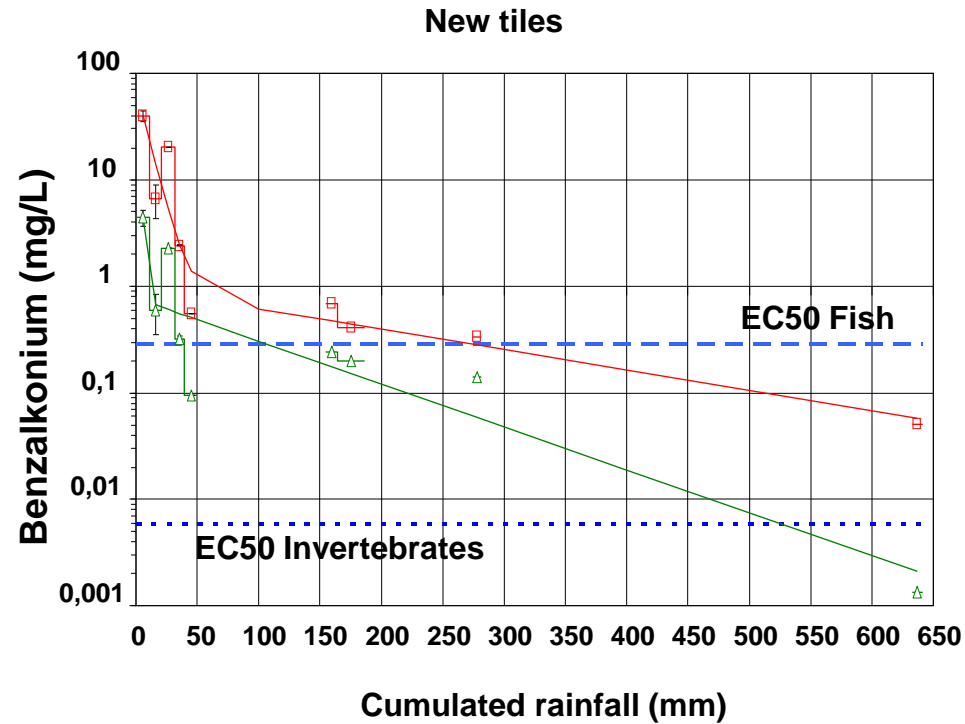
■ Concrete ▲ Ceramic tiles

Emission level depends on the tile material
But not on the exposition

Very high concentrations in the first runoff events
Rapid first order decrease

Persistent emissions even after 13 month

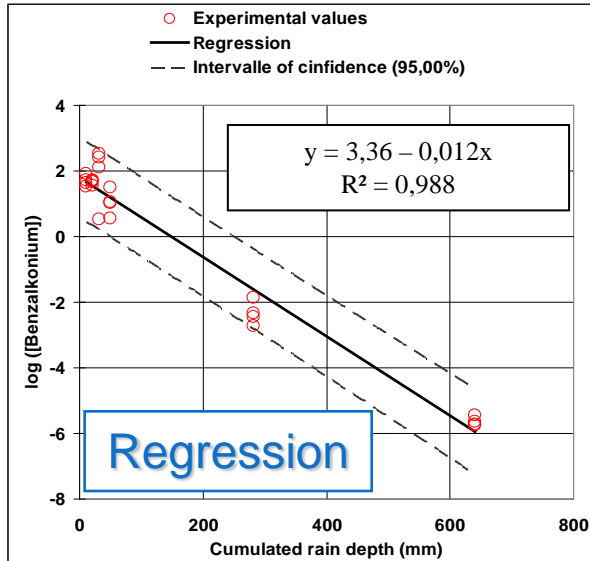
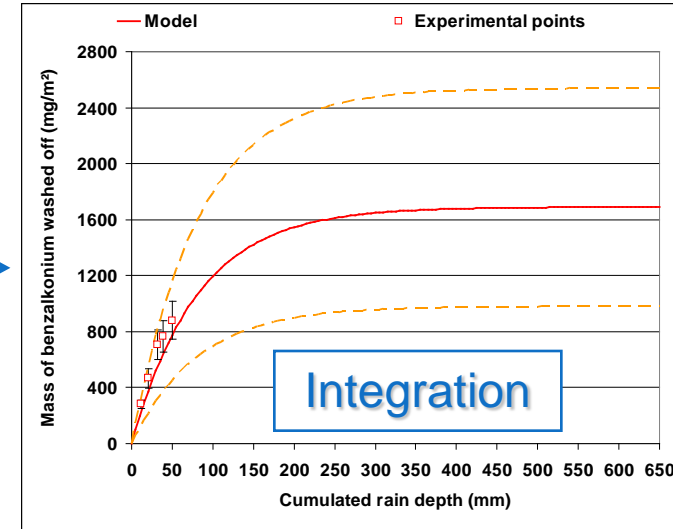
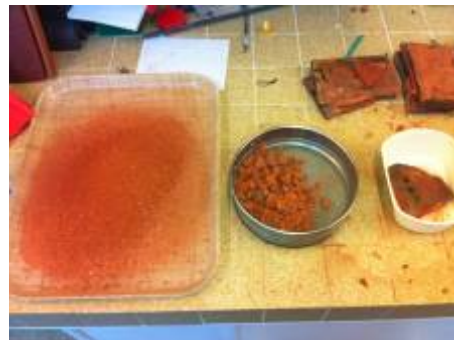
Product dilution and analysis

Extraction and analysis

- Benzalkonium trapped in material negligible compared to mass spread (0.5 - 2%)
- Mass washed off dominant for both concrete and clay
- Low recovery (especially for clay) → could indicate biodegradation processes

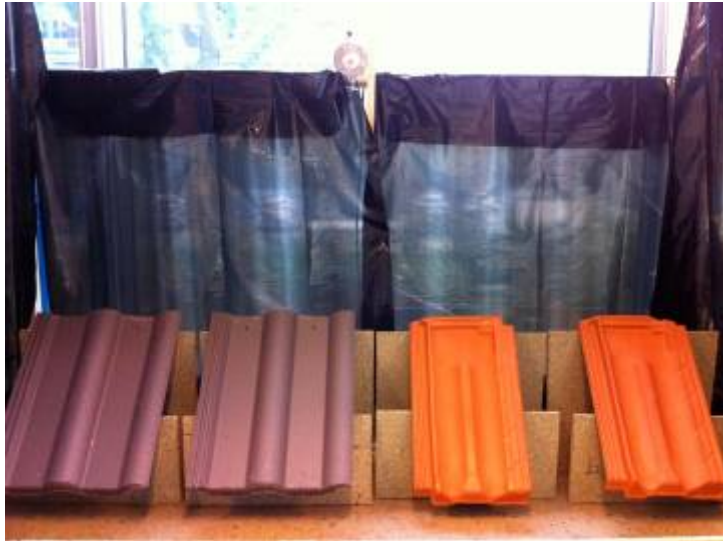
Emission patterns depend on the surface treatment of tiles

→ Impervious surface : fast leaching proportional of the mass spread

→ Pervious surface : product penetration and long term emission

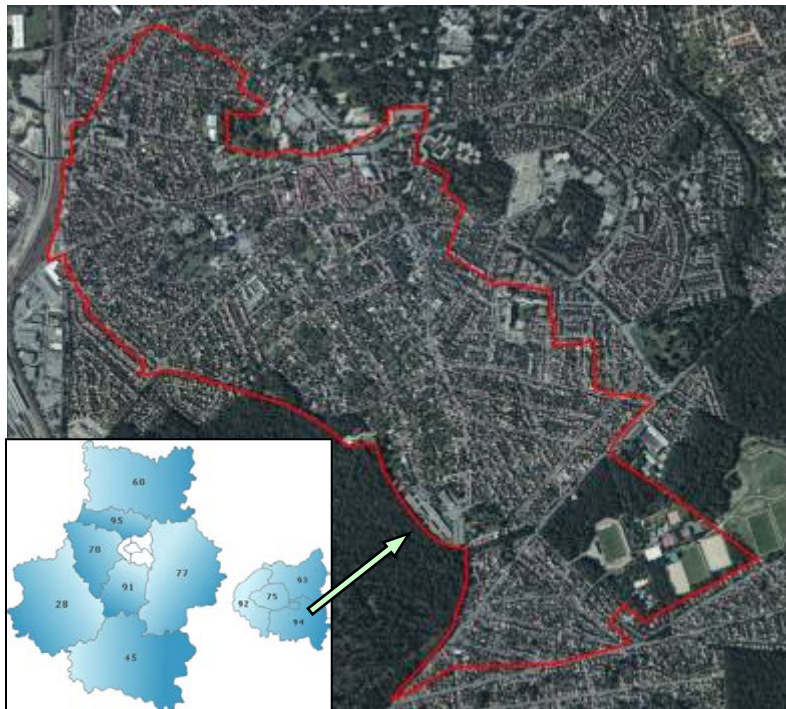
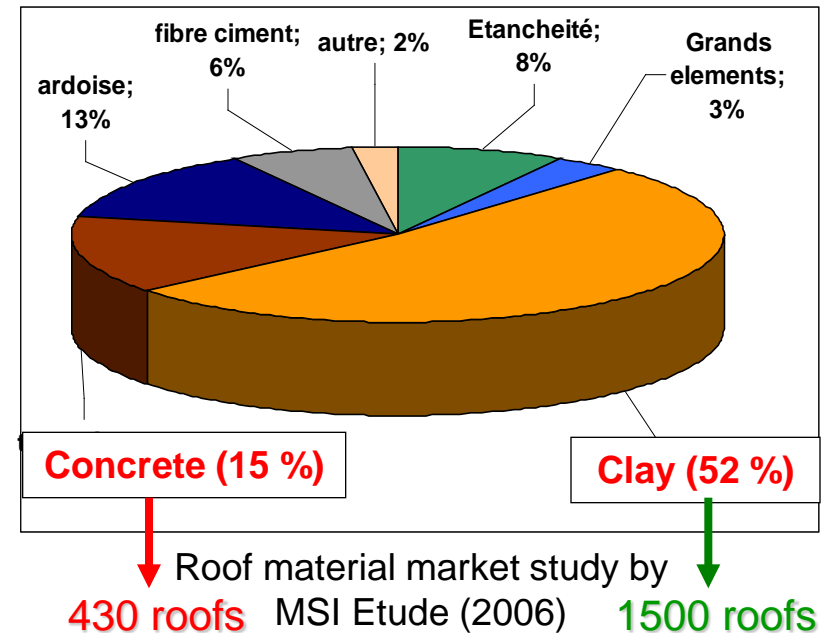
Sucy en Brie catchment

Total area (km ²)	Imperviousness (%)	Road area (km ²)	Roof area (km ²)	Number of treatable roofs
2.1	30	0.325	0.315	2850

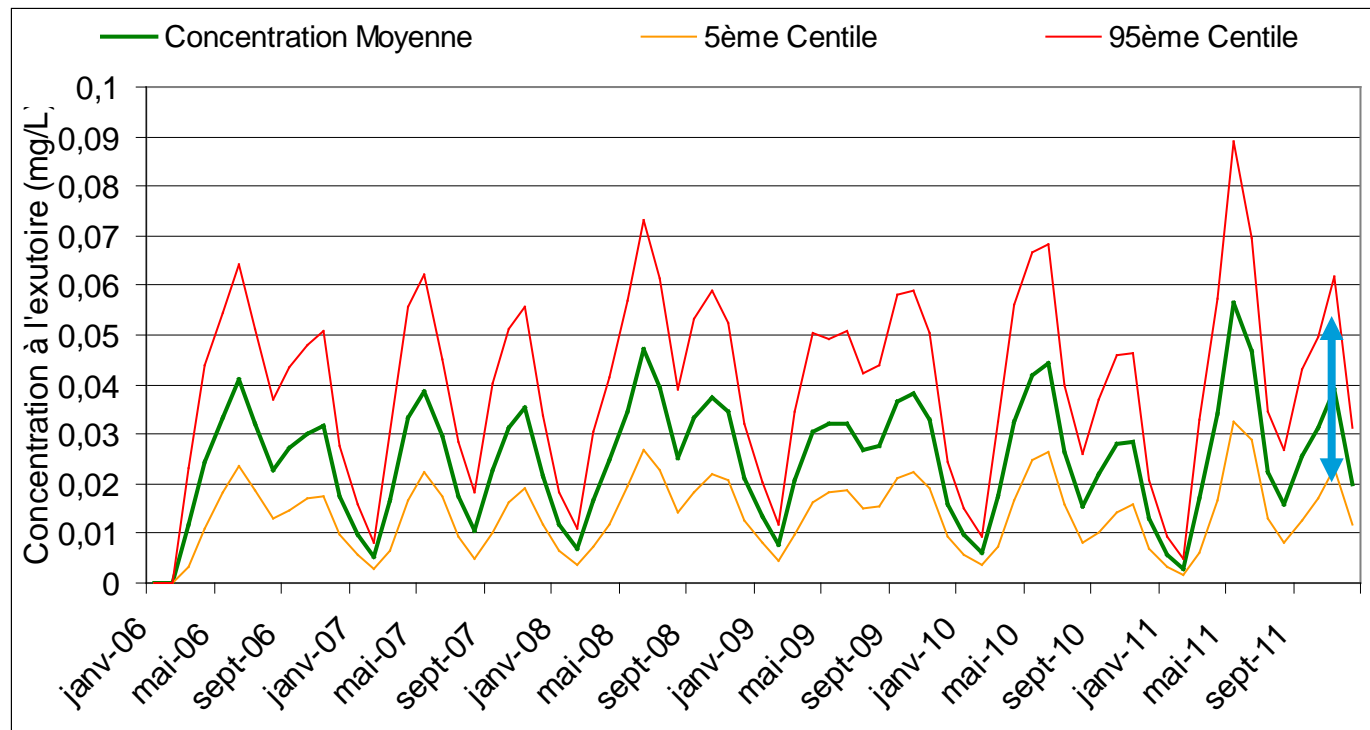
- Simulated stormwater concentration ranges at the outlet of Sucy catchment

- *Strong annual pattern linked to treatment periods*
- *Rapid decrease in periods without treatment*
- *Strong uncertainty due to variability in treatment practices*
